Surgical technique

Protection of the Femoral Trunnion During Acetabular Revision Hip Surgery—A Novel Technique

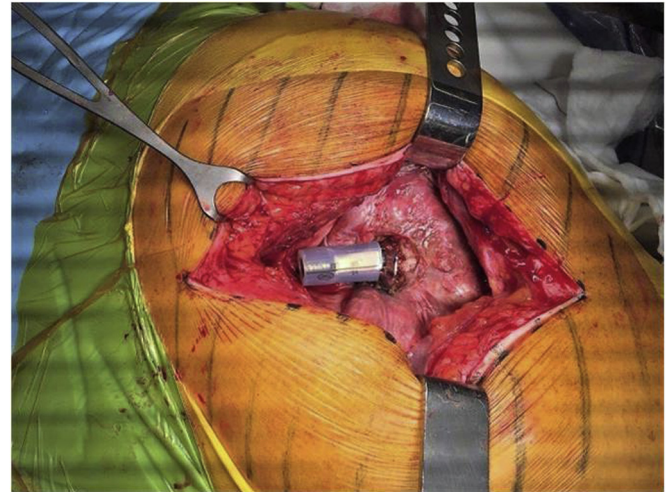
Figure 2. Intraoperative photograph of femoral taper protection with the laryngeal airway sleeve.

For the posterior approach, the femoral prosthesis is then retracted anteriorly into a subgluteal pocket. A curved Hohmann retractor is placed anterior to the acetabulum with the femoral component levered behind it. The silicon sleeve protects the trunnion from metal-on-metal contact and scratching in spite of leverage directly by the instruments (Fig. 2).

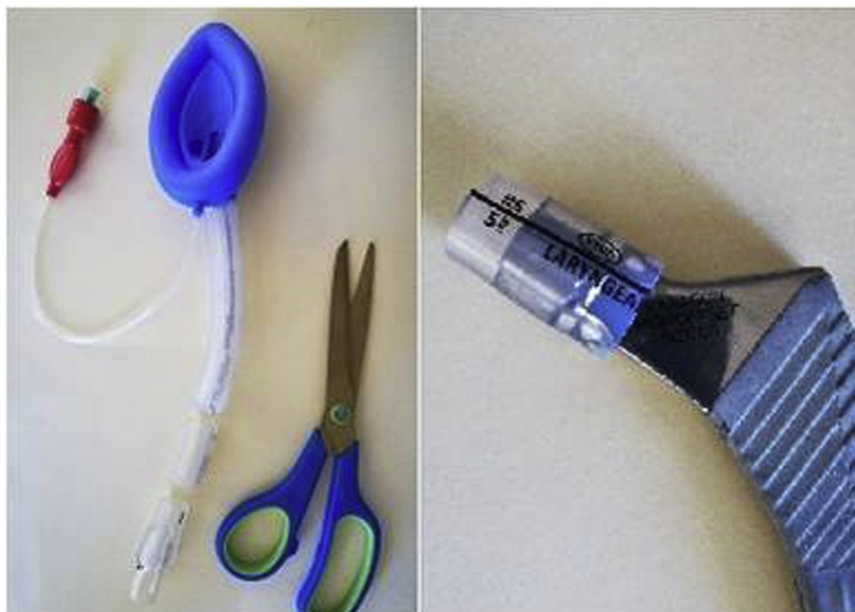
Figure 1. Silicon laryngeal airway #5 and its cut segment applied to the femoral taper.

We use a mini-posterior approach, but the technique is applicable to all surgical approaches. After dislocation of the hip, the femoral head is removed and the taper inspected and cleaned. A 1-inch segment of #5 laryngeal airway is applied directly over the Morse taper (Fig. 1). This tubing seems to fit snugly for tapers

ranging from 11/13, 12/14, to even rarely 14/16. It is less tight on the smaller tapers such as V40.
